Evaluation Report for an Archaeological Collections Center for the Presidio Trust San Francisco, California

Architectural-Archaeological Report
Series No. 6

Mandatory Center of Expertise for the Curation and
Management of Archaeological Collections

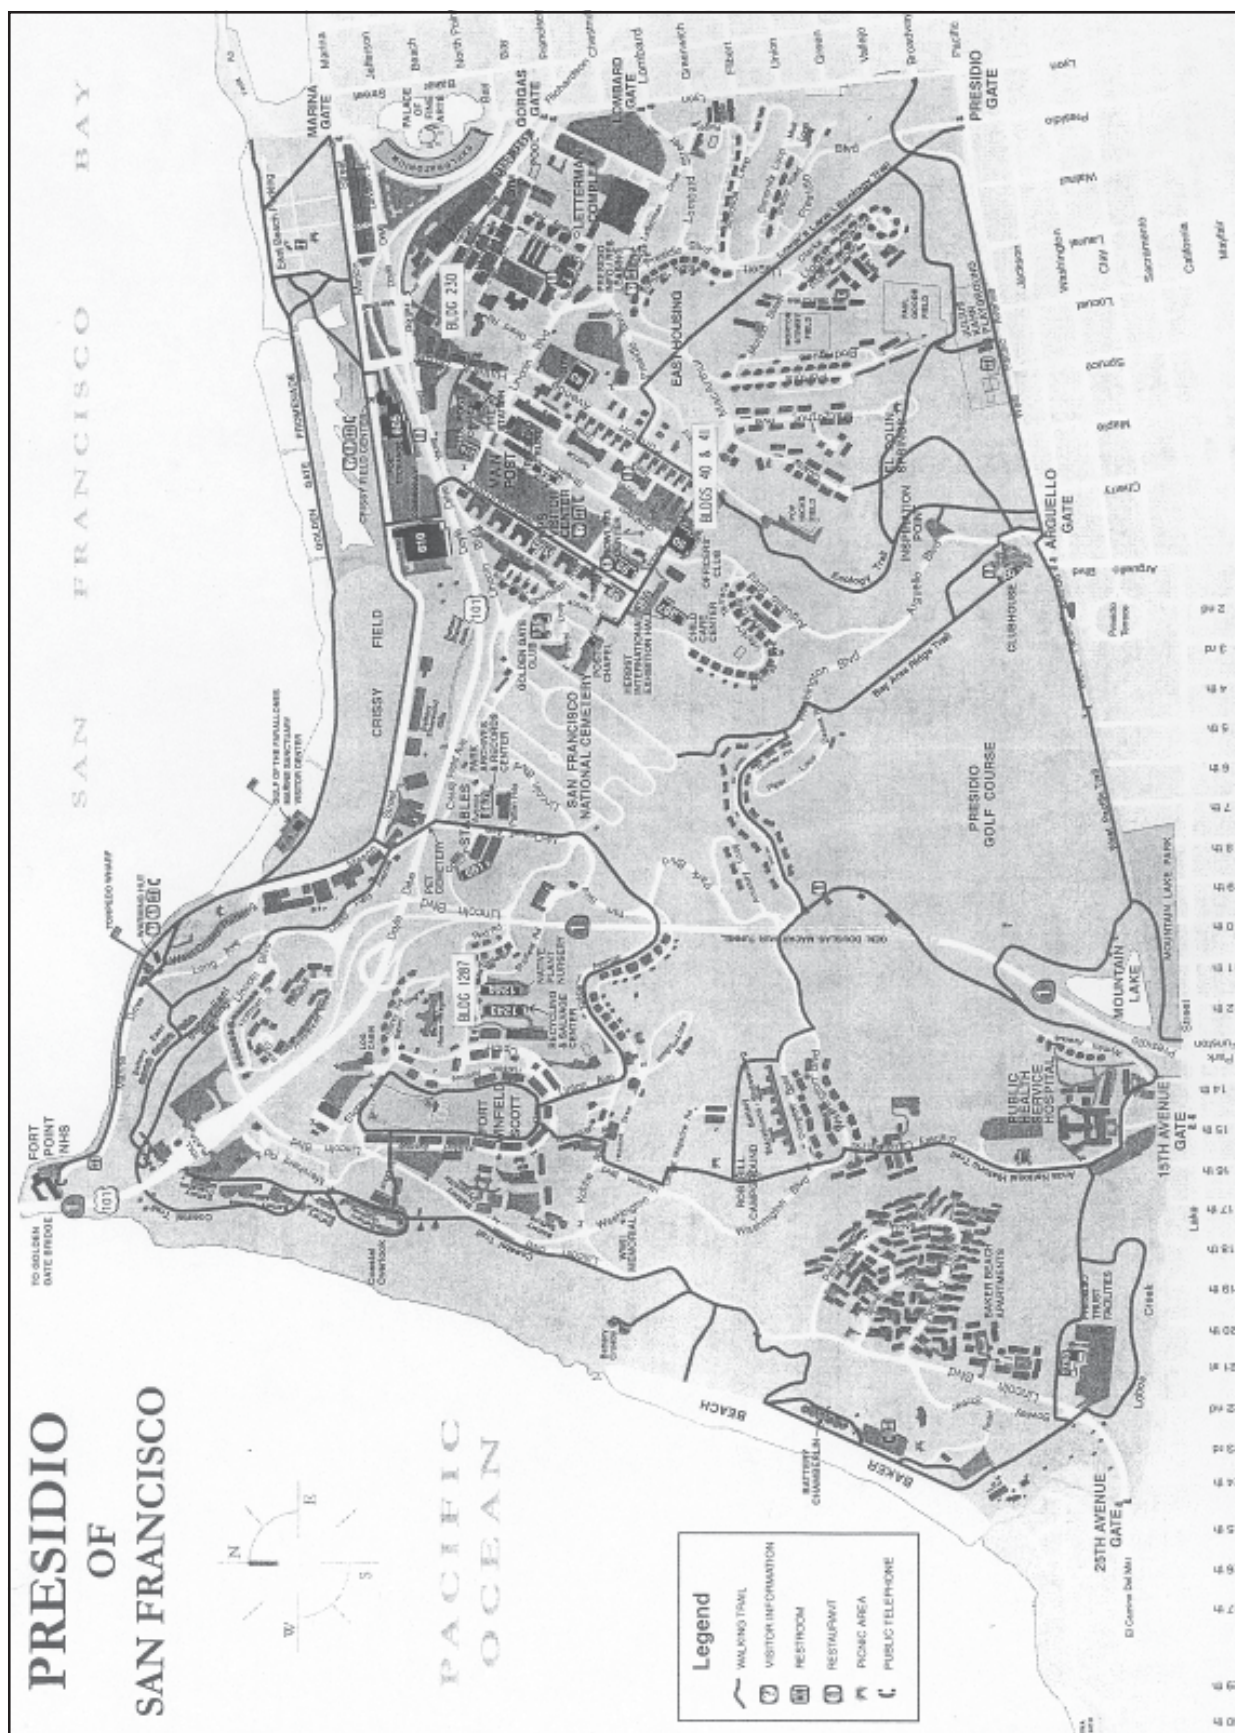
Figure 1. Site plan of the Presidio of San Francisco.

The Presidio of San Francisco is located within the 75,500-acre Golden Gate National Recreation Area, the world’s largest national park in an urban setting (Figure 1). The Presidio of San Francisco is registered as a National Historic Landmark District (NHLD). The Presidio, which is south of the Golden Gate Bridge and adjacent to San Francisco, California, comprises 1,491 total acres, with 991 acres of open space.

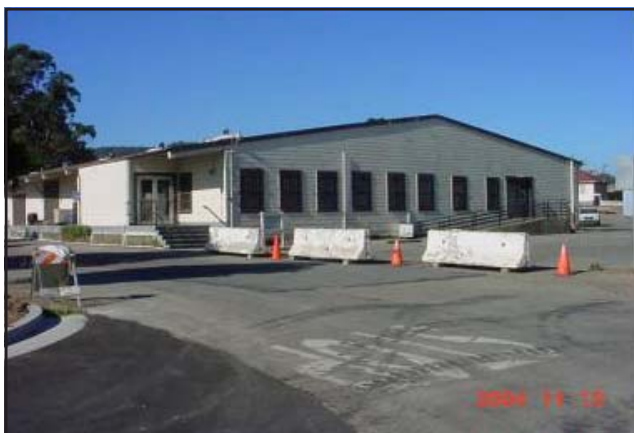
Figure 3. Exterior view of Building 230, the Presidio Archaeology Lab.

Presidio Trust archaeological collections and associated records are housed in the Presidio Archaeology Lab, Building 230 (Figure 3). Building 230 is located on the outermost edge of Area B of the Presidio complex, on the corner of Gorgas Avenue and Doyle Drive. In addition to

Building 230 is easily accessible from major city streets and highways and has ample parking for visitors and researchers. The building is located in an earthquake zone along the San Andreas Fault. The building foundation is poured concrete with a wood-siding exterior and a shingle roof. The staff indicates that there were no observable cracks or leaks in either the foundation or the roof. Windows, which have wood frames with metal bar overlays, are not completely airtight or watertight. Roof ventilators, which allow air to vent to the exterior, are covered to prevent heat loss in the fall and winter and to keep birds and pests from entering the repository.

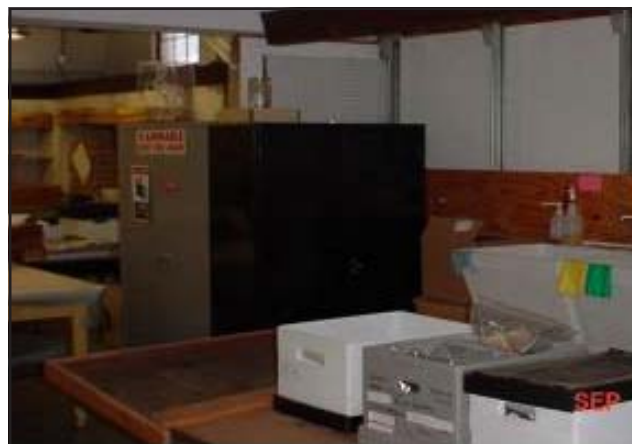
Figure 4. Hazardous chemicals cabinet in Building 230.

Building 230 encompasses 10,547 ft² and is divided into the following components: receiving/loading dock, artifact storage area, artifact holding area, artifact washing area, artifact processing laboratory, temporary artifact storage area, hazardous materials storage area, exhibit area, photographic dark room, refrigeration units, materials/supplies storage area, mechanical/utility areas, library, kitchen, and offices. A museum specimen cabinet is used for special leather items and for spent ordnance. Hazardous substances (e.g., acetone and acryloid B72) are stored in a locked cabinet next to the artifact washing and processing area (Figure 4). An emergency eye wash/shower is located in Building 230, but no fume hood has been installed.

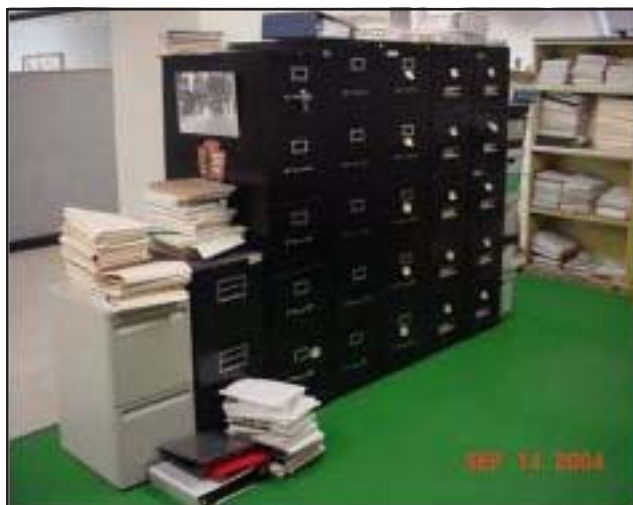
Figure 5. Metal file cabinets in records storage area.

metal shelving units, in banker's boxes, on wooden desk tops, and on the floor (Figure 5). Record types include maps and reports, and field, photographic, analysis, administrative, and miscellaneous records for both Presidio Trust and NPS collections. Reports are arranged within cabinet drawers by the author's last name; however, other record formats are not arranged in any specific order.

Within the storage units, the documents are stored in a variety of secondary containers, including acidic manila folders and envelopes, colored folders, plastic folder covers, spiral and bound notebooks, and three-ring binders. Some documents are stored loose within the drawers (Figure 6). Staples, paper clips, and tape are present on many of the documents.

1. In order to store, label, maintain, and conserve the associated records using professional museum and archival practices [36 CFR Part 79.9(a) and 79.9(b)(6)], the following minimal tasks should be performed. All foreign objects (e.g., paper clips, staples, tape) should be removed from the documents. The records should be placed in appropriately labeled, archival primary and secondary containers (e.g., fire-proof file cabinets and/or acid-free file boxes and folders). Records should be stored in a manner that will protect them from fire, theft, damage, and destruction. A folder-by-folder finding aid for the collection should also be created and files should be cross-indexed.

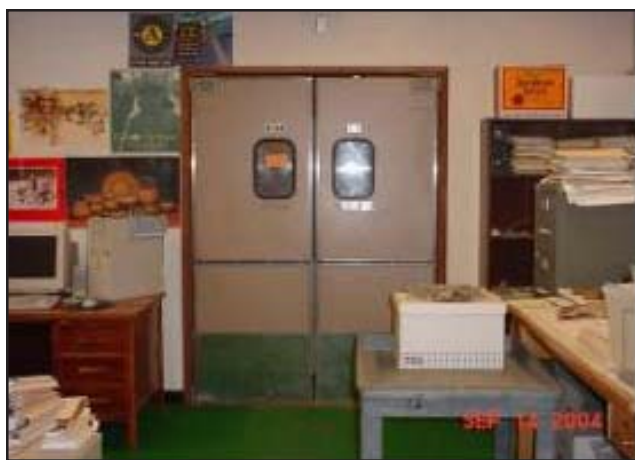
Figure 7. Door leading to the back storage room.

The back storage room currently holds all archaeological collections from the Presidio Trust (except those collections on loan at several universities), along with a few NPS collections. The room, which also houses field equipment, is at 80–90% capacity. The doors leading to the back room are unlocked at all times, but individuals can enter the room only with permission from the curatorial staff (Figure 7). A loading/receiving dock door is located within this room and is locked at all times, except when loading and unloading field equipment. Temperature and humidity are monitored in the back storage room.

The Presidio Trust archaeological collections are stored near the window. These windows are not covered (e.g., commercial shades, blinds). The floor load is sufficient to support the weight of the materials currently held and those slated to be placed there in the future. There are no immediate plans to use the back room for activities other than storage of archaeological collections and field equipment.

3. In order to protect the collections from breakage and possible deterioration from visible light and ultraviolet radiation [79.9(b)(5)(ii)], window coverings (e.g., commercial shades, blinds) should be purchased for the windows in the collections storage area.

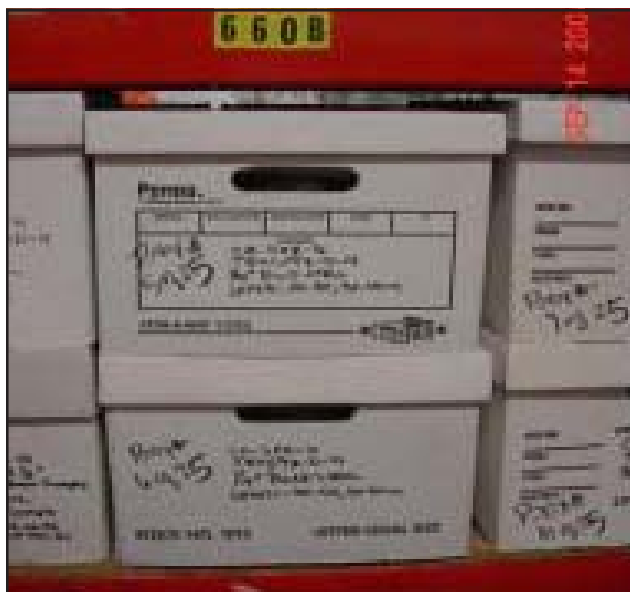
Figure 8. Close-up view of boxes of Presidio Trust collections.

Presidio Trust archaeological objects are housed on metal shelving units in chloroplast® boxes and acidic bankers boxes (Figure 8). Oversized artifacts are stored loosely on the bottom shelves. Boxes have adhesive labels attached to the fronts or are directly labeled in marker. Labels list any combination of the following information: project, site number (if applicable), field site/feature number, material class, provenience, and box number.

5. Some metal shelving units in the back storage room are beginning to rust. These shelves [79.9(a)] should be replaced with newer metal shelving units and lined with acid-free paper.

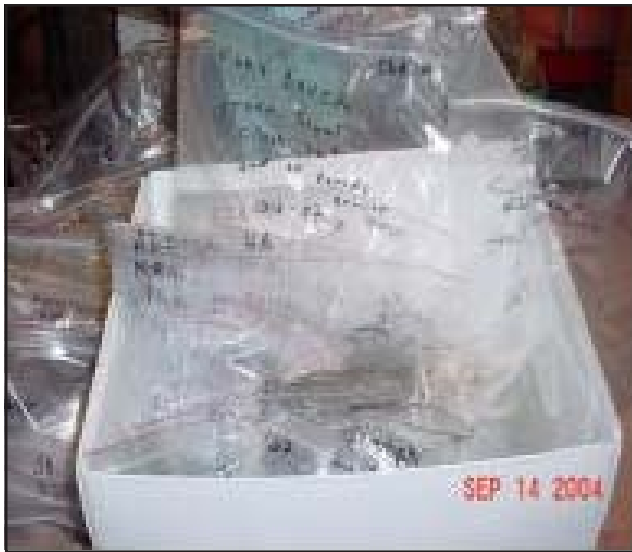
Figure 9. Secondary containers for Presidio Trust artifacts

Within the boxes, artifacts are stored in plastic 2-mil zip-lock bags. The bags are in good condition with few visible punctures (Figure 9). Loose artifacts have attached cotton string tags or other attached paper. Bags are directly labeled in marker with the project, catalog number, location, material class, description, and date. All artifacts have been sorted and cleaned. Artifacts are sorted by project and year and are directly labeled with the catalog number.

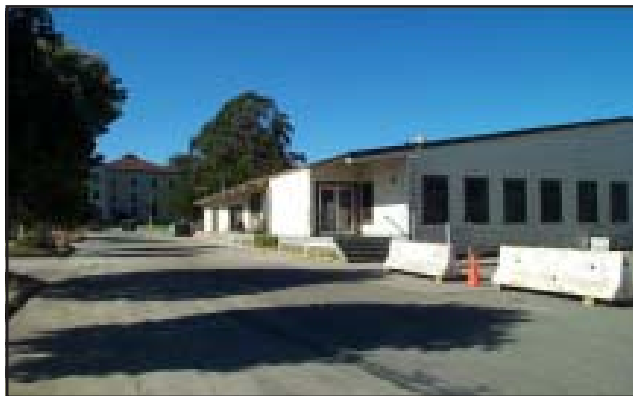
Figure 10. View of main entrance to Building 230.

Building 230 (Figure 10) was constructed in 1917 and originally used as a warehouse. Over the years, it has undergone several modifications to accommodate various uses such as Base PX, a furniture store, a clothing store, a toy store, and its current use as an archaeology laboratory. Due to

planned highway construction, Building 230 is slated for demolition in the next five-to-ten years. Total building floor area is 10,547 square feet. The floor area in Building 230 (Figure 11) will be used as a baseline for comparison to the other buildings evaluated in this report.

Building construction consists of a concrete pier and a spread footing foundation system. Spanning across the piers are 12-x-12-inch wood girders, or four built-up 3-x-12-inch wood girders. Spanning above and across the girders are 3-x-14-inch wood joists spaced at 24 inches on-center. Above the wood joists are 2-x straight sheathing planks. Exterior walls consist of wood siding on wood studs. Roof construction consists of red composition shingles on wood sheathing on 2-x-6-inch rafters that span to double 2-x-12-inch wood beams. The wood beams are supported by 6-x-6-inch wood columns.

Building 230 has served reasonably well as the archaeology laboratory and collection storage facility at the Presidio since 1998. It would appear to be capable of doing so for the remaining years of its expected lifespan. Several recommendations are proposed in Chapter 4 that would enhance the building's usefulness as a curation and public education facility during the remainder of its tenure.

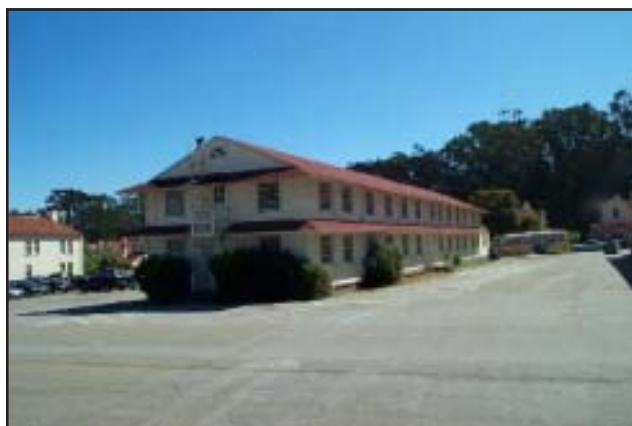
Figure 12. View of front entrance to Building 40.

Building 40 (Figure 12) was constructed in 1941 as a Bachelor Officers' Quarters to accommodate the sudden increase in military personnel during the early part of World War II. This type building was considered a standardized temporary barracks building. Building 40 was used as an officers' barracks until the Presidio was decommissioned in 1994. Aside from some interior modifications and

the addition of a shed-roof wing on the east wall, very few structural changes have occurred to this building since its construction. The building is currently vacant. Total floor area is 8,234 square feet (4,356 square feet at the first floor and 3,878 square feet at the second floor).

Based on the above noted inspection and evaluation, it is not recommended that Building 40 be considered for use as a permanent archaeology laboratory, office space, educational and exhibit area, or collections storage facility.

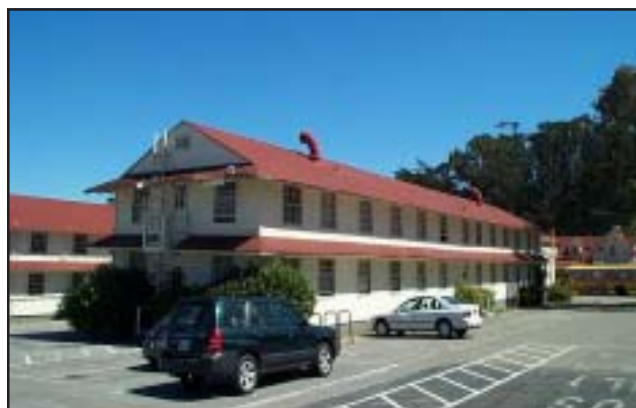
Figure 15. View of front entrance to Building 41.

Building 41 (Figure 15) was constructed in 1941 as Bachelor Officers' Quarters and is located next to Building 40. This type building was considered a standardized temporary barracks building. Building 41 was used as a barracks until the Presidio was decommissioned in 1994. Aside from some interior modifications and the addition of a shed-roof wing on the east wall, very few structural changes have been made to this building. The building is currently used for rental housing. Total floor area is 8,246 square feet (4,381 square feet at the first floor and 3,865 square feet at the second floor).

The parking lot lacks ADA-compliant parking spaces and an accessible entrance into the building. Exits from the second floor consist of an interior discharge stair near the center of the building and exterior fire escapes at each end of the building. None of the exits meet current code requirements. Restroom/shower facilities are located within the individual suites. None of these facilities were found to be ADA compliant.

The building is equipped with a sprinkler system. It was not determined during the site visit the date when the sprinkler system was last inspected. Smoke detectors are located along the ceiling. A fire alarm annunciator panel is located in the lobby near the central entrance. It is unknown if the fire alarm is wired to the Presidio Fire Department. The mechanical system consists of a gas-fired boiler with radiant heat. The boiler is located in the mechanical room at the first floor. Access to the mechanical room is through exterior entry doors. A 100-amp electric panel is located at the first floor near the stairwell, and another 100-amp electric panel is located at the second floor near the stairwell.

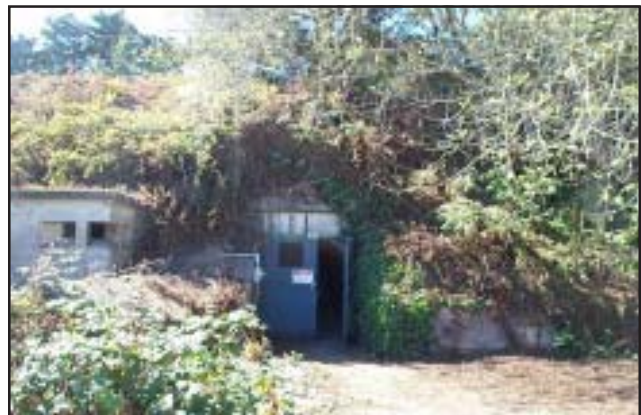
Figure 18. View of entrance to Building 1287.

Initial construction of Building 1287, Battery Howe-Wagner (Figure 18), began in the 1890s but was not completed until 1913. The facility was a mortar battery and formed part of a large-scale improvement of San Francisco's harbor defenses. The battery originally mounted 16 12-inch mortars. The original battery was laid out in a cross-shaped plan, with four mortars in each arm of the cross (Figure 19). This cross-shaped plan was unique for San Francisco coastal defenses, as all other batteries were linear in plan. The battery was later divided into two units, Battery Howe comprising the two east pits of the original installation, and Battery Wagner comprising the two west pits. In 1920 the mortars were dismantled and the battery was converted to a storage facility. After 1950, three of the four mortar pits were buried under an earthen mound. The single pit left exposed was the mortar pit located at the northeast corner. An entrance near the northeast mortar pit leads to the former magazine and service rooms. A wood frame and corrugated iron garage building (Building 1285), erected in 1933, presently occupies the former northeast mortar pit emplacement. Building 1287 is currently used for

storage of earthquake supplies and other Presidio supplies. Total floor area is 7,304 square feet.

Building 1287 was inspected as a potential collections repository only, with no planned laboratory, office, or public spaces since the structure is an underground bunker. The MCX does not recommend the use of Building 1287 as a collections facility. Although the building provides adequate space, humidity problems and mold growth in the facility would be a serious long-term concern for the collections, even with updated mechanical systems. Failure of a system for even a few days could allow mold growth, potentially causing irreversible damage to the collections. Additionally, the building lacks adequate fire/emergency exits, fire and security alarms, and a sprinkler system. Finally, there is no space for the construction of a loading dock or even adequate truck maneuvering space near the building; moving collections and supplies would prove difficult.
